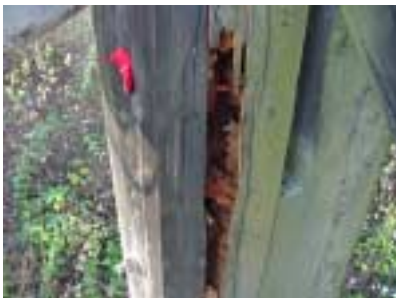
Red Tagged Timber Column

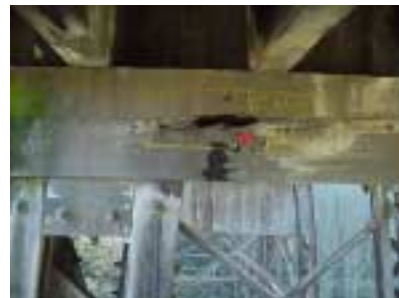
Red Tagged Pier Cap

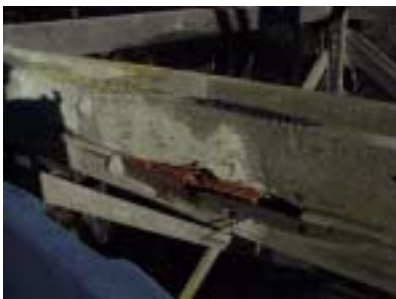
Red Tagged Horizontal Brace

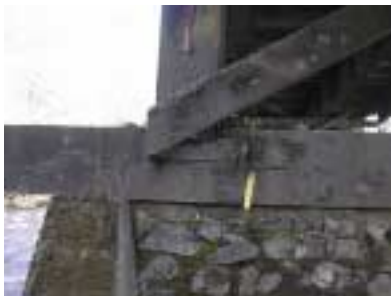
***Red Tagged Column & Yellow
Tagged Cap on Rubble Pier***

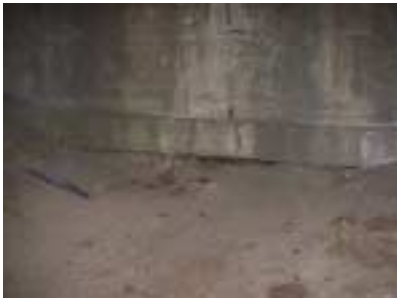
Soil Sloughing Beneath Pier

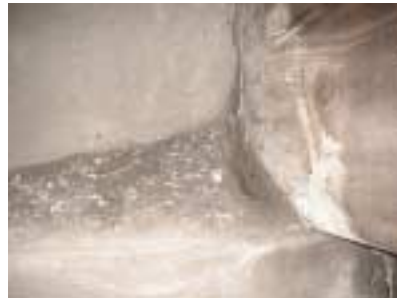
Girder Exposed to Soil at Abutment

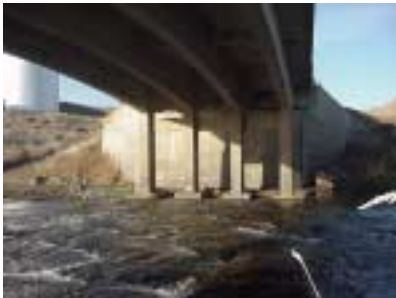
Exposed Column Footings

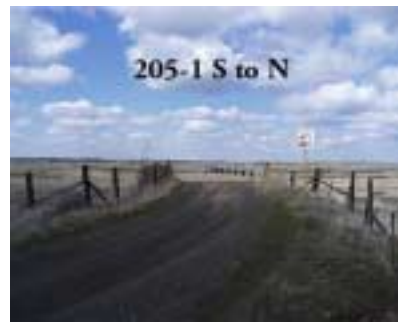
205-1 S to N

Deck View with Load Posting

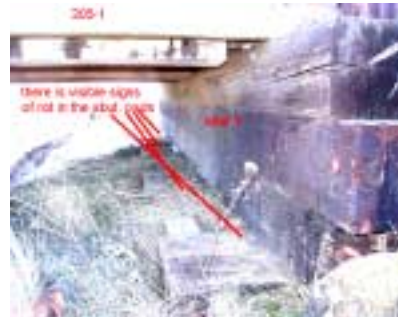
Timber Abutment Elements in Contact with Soil

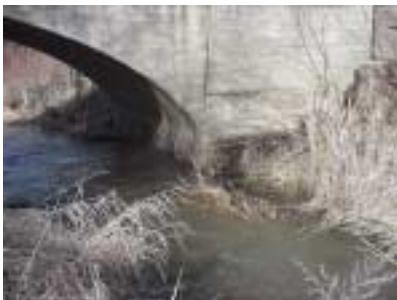
Scour at Bridge Corner

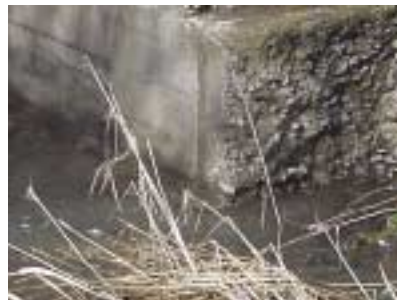
Concrete Scaling at Scour Hole

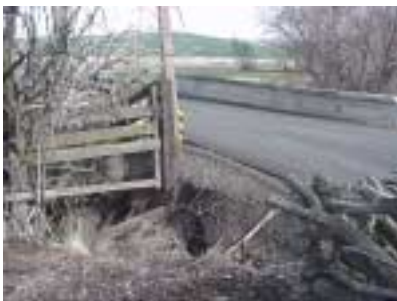
Walla Walla County Evans Bridge

Sloughing at Bridge Corner

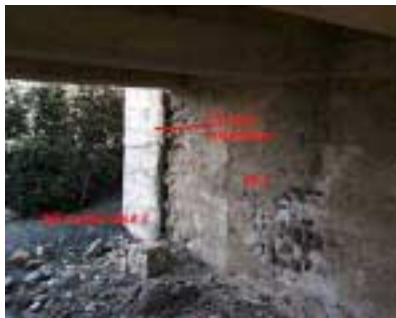
Adams County Weber Bridge

View Showing Widening

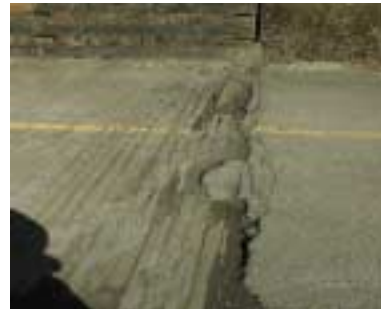
Cowlitz County Imboden Bridge

Approach and Timber Deck Interface

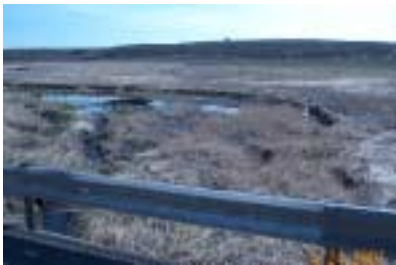
Lincoln County Cook Bridge

View of Channel Facing East

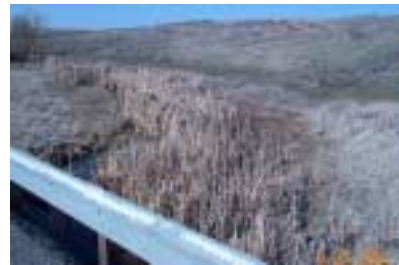
Lincoln County Cook Bridge

View of Channel Facing West

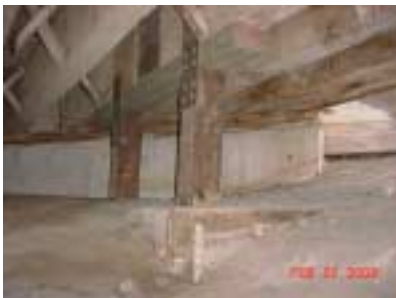
Franklin County Crestloch Road Bridge

Temporary Timber Shoring

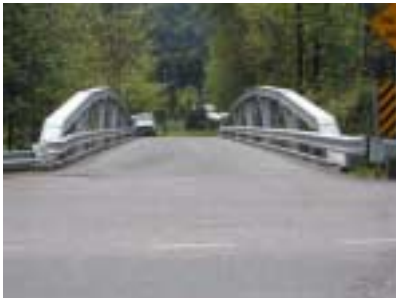
Lewis County Garnet Bridge

The Narrow Bridge Lets onto a T-Intersection

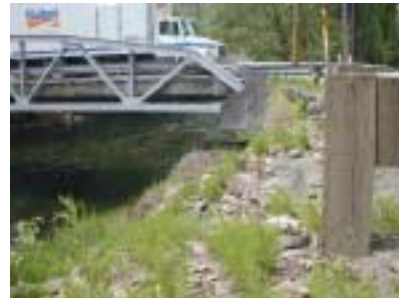
Lewis County Garnet Bridge

Erosion at Abutment

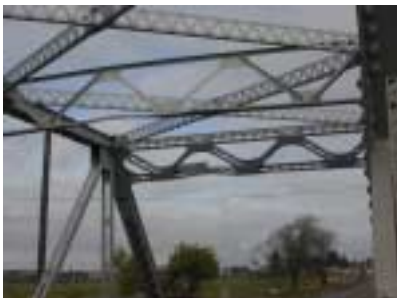
Lewis County Newaukum Bridge

Portals and Sways Have Been Hit

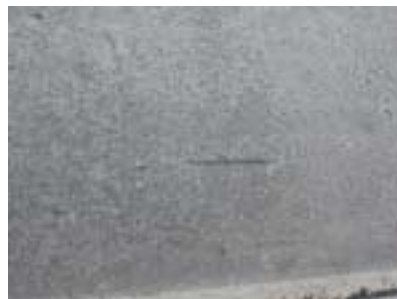
Lewis County Newaukum Bridge

Exposed Reinforcing Steel in Deck

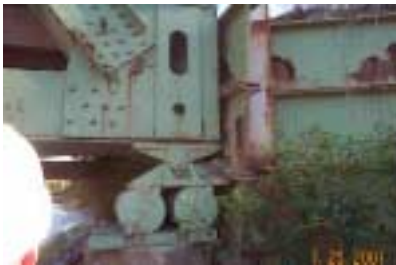
Stevens County Barstow Bridge

***Roller Bearings at Pier 3 – Bridge
has Impacted the Abutment Backwall***

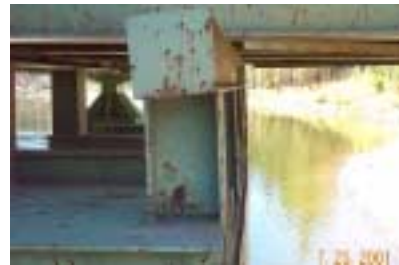
Stevens County Barstow Bridge

Span 1 Bearing at Pier 2

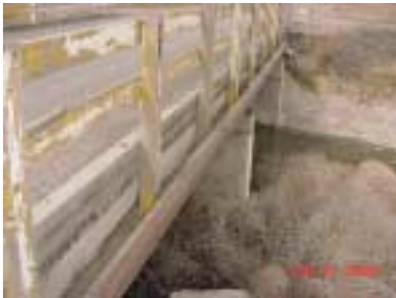
Franklin County Everett Road Bridge

***Weathered and Split Railing
Components***

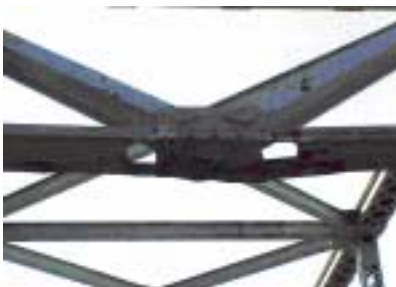
Stevens County Hedlund Bridge

High Load Hit

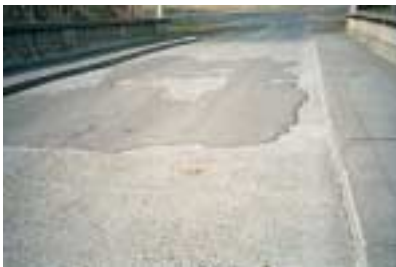
City of Waitsburg Main Street

Deck Scaling

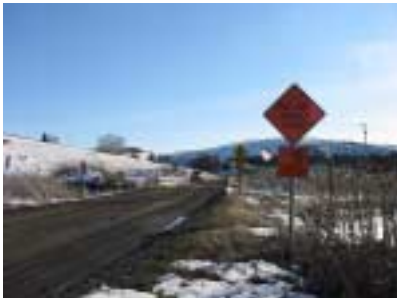
Restrictive Signing

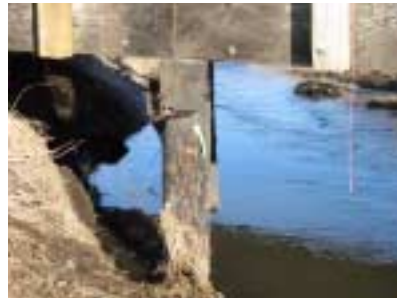
Shifting Timber Bent

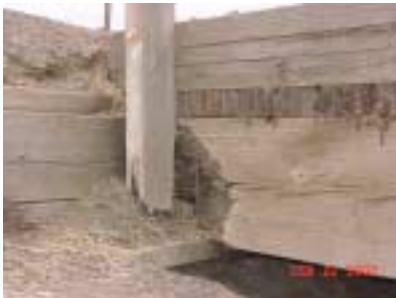
Rotten Timber Members
